UNSAFE AFTERMARKET STEERING COLUMNS

UNSAFE AFTERMARKET STEERING COLUMNS (Continued)

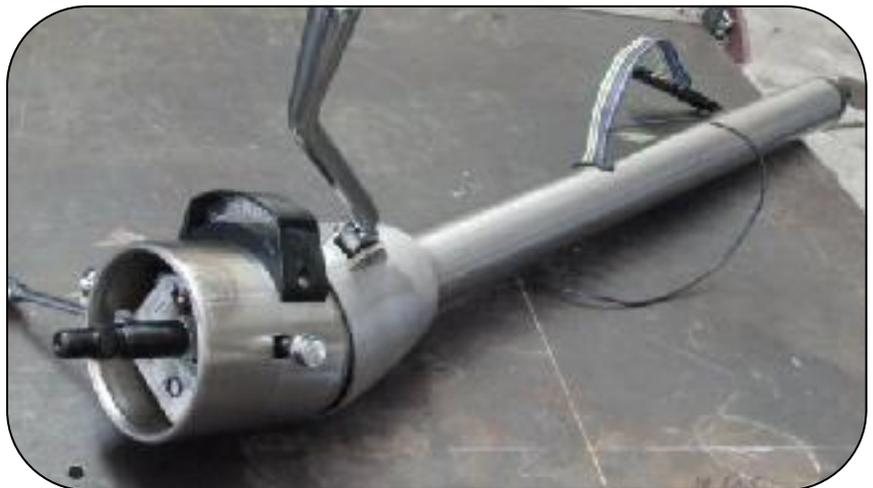
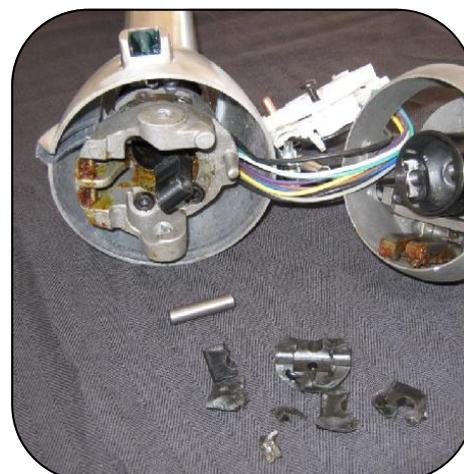
The aftermarket tilt steering column above is the brand new 'Helix'- brand unit that failed in service.

The connection between the upper and lower steering shafts relies upon the plastic bush and pin system used to operate the tilt mechanism, which completely collapsed, shown in the photo at left.

LVVTA has dismantled and inspected a number of these aftermarket steering columns, and many have been found to be defective and unsafe, in that they are not 'fail-safe' by design, and some of the components within some columns (upon which the directional control of any vehicle to which such a column is fitted is reliant) are made from poor-quality plastic bushes, attached by insufficiently-engaged pinning systems. Some of the aftermarket steering columns inspected feature very poor-quality welding of the various welded sections of the internal steering shaft. Many of the columns LVVTA has inspected incorporate an unacceptable amount of free-play within the tilt mechanism, even in brand-new unused condition.

On April 29, in the midst of LVVTA's investigation, one such aftermarket column completely failed whilst in operation, causing the driver to experience a total loss of directional control - although thankfully at low speed without resulting in any damage or injury.

The brand that LVVTA considers to be the most unsafe (and not coincidentally the one that failed) is the 'Helix' brand, manufactured by an American-based company known as the Hoffman Group.

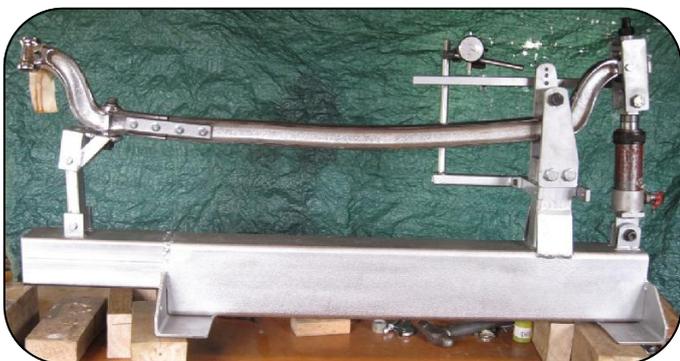
The specialised beam axle support test rig (above) was designed and built by LVVTA Technical Committee Member Chris Litherland.

To move forward from this impasse, a range of strength tests and tensile tests have been carried out by LVVTA during early 2013, the results of which have completely stumped even qualified metallurgists. The performance of the low-ductility (non-compliant) axles in both the strength tests and the tensile tests was found to be very similar to the axles with a high ductility value (compliant axles). It would seem that the material composition of the low ductility axles somehow compensates for the low ductility by the inclusion of some other material or chemical.

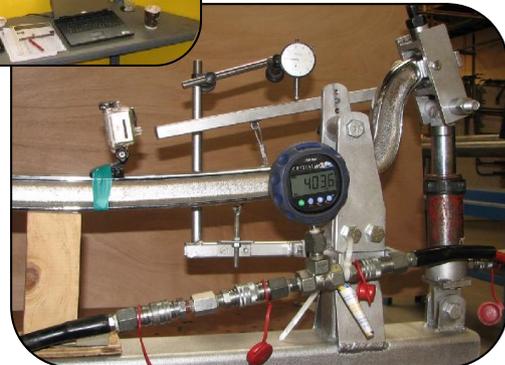
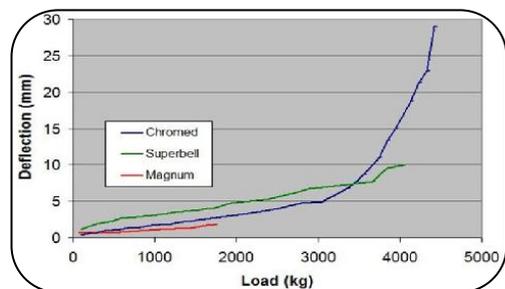
The series of axle strength tests, for establishing both yield and ultimate failure of three different axles, were carried out at by LVVTA at a test facility kindly made available by Peter Jackson of Jackson Enterprises in Auckland.

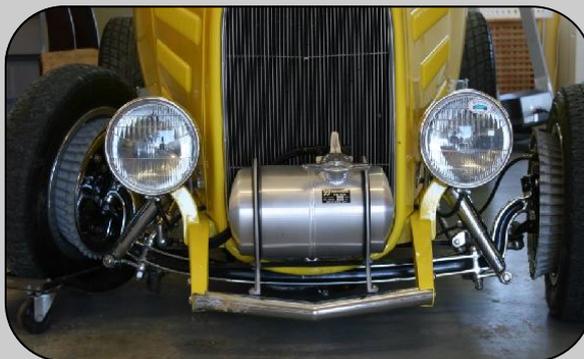
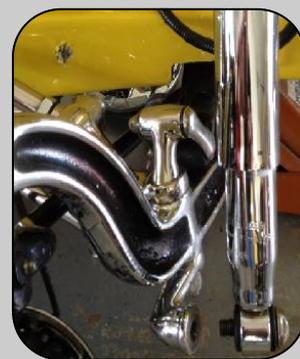
Good Outcome from Crash

The result of this low-speed right-front wheel impact shows substantial bending on this aftermarket axle, but no failure - performing exactly as it should. The only other damage was bent spring shackles (not the spring), bent tie-rod (but not the steering arms), and bent shock absorber and hairpin radius rod. No bolts or brackets sheared.

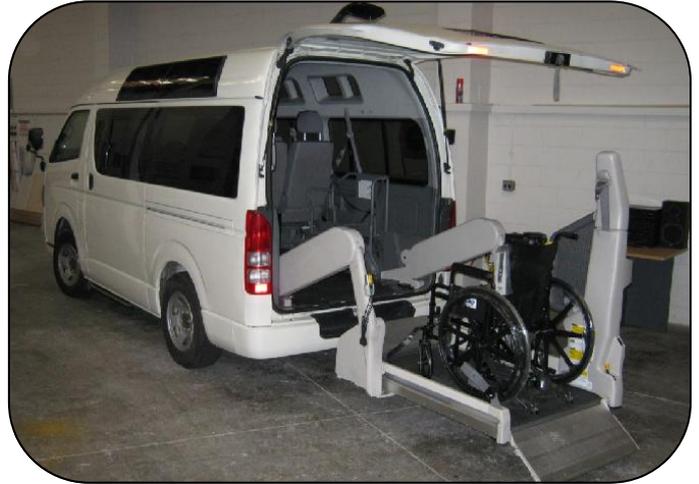
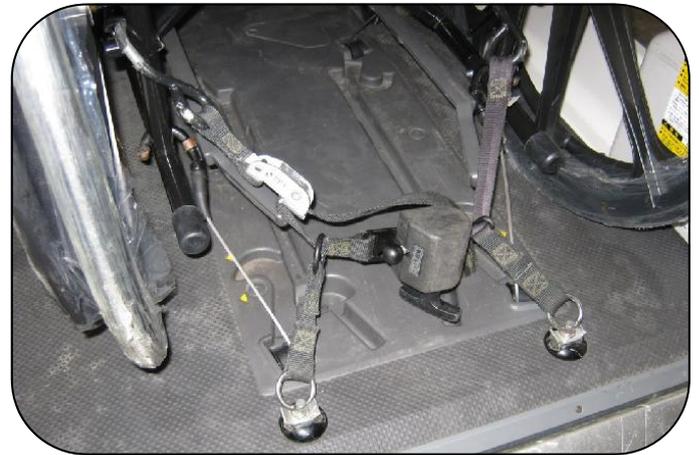
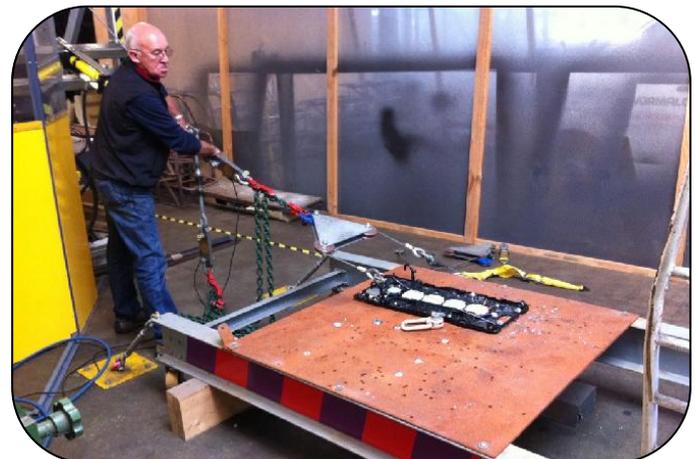
One feature is a wheelchair tie-down system mounted on the hoist that incorporates automatically-tightening hooks on metal wires, together with webbing straps. The hoist incorporates a lap and diagonal seatbelt and is a good use of the space. However the Disability Transportation Systems Standard prohibits hoist-mounted wheelchair anchorage positions. This system does not have any standards markings, and test data has not been made available to prove its load capacity. This has meant that the system would have to be replaced with approved tie-down straps, which is not possible on the hoist.

Note that wire restraints that are not on the hoist should be replaced with standards-compliant restraint systems.

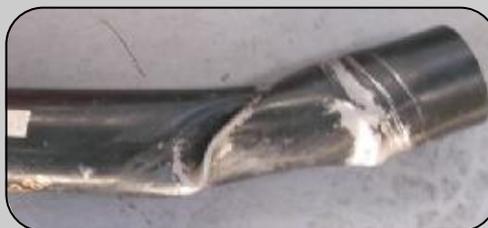
And it Still Drove!

From Canterbury-based LVV Certifier Don Hoff; - the owner of a Daihatsu Rugger to which this OE driveshaft was attached got a surprise, after doing some rough off-road work in a river-bed, found a pretty bad drive-shaft vibration - though not until he drove the Rugger out of the river-bed and back onto tar-seal!

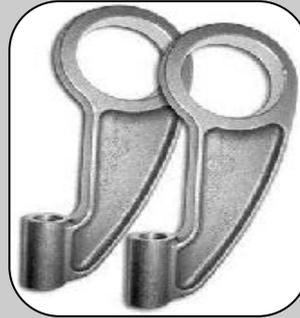
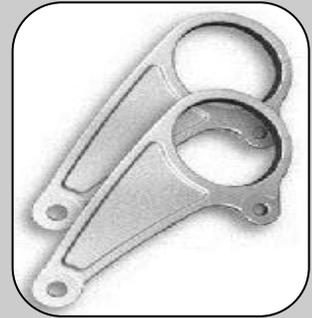
LVVTA cautions LVV Certifiers and vehicle owners to avoid the forged 'SO-CAL'-brand of rear end housing brackets for ladder bars, and for transverse leaf springs. LVVTA are not aware of any problems with the brackets themselves (and SO-CAL products are generally good), but as they are manufactured via a forging process, welding them to a diff housing is not allowed in New Zealand. LVVTA maintains a strong philosophy of disallowing any welding in a critical location or component in the case of forgings or castings.

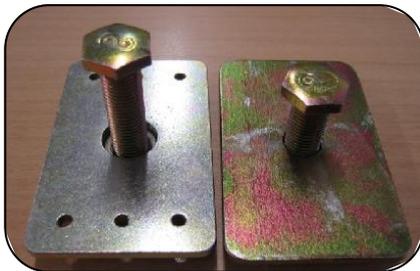
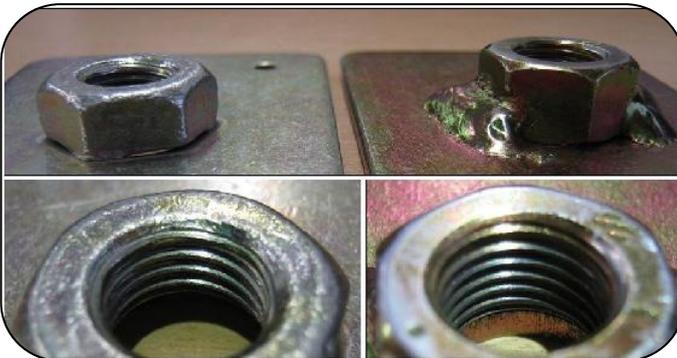
Seat & Seatbelt Anchorage Doubler Plates

The plates that do not meet the requirements have a slim-line nut which is held on by 3 small projection-welds. The plate has a 16.5 mm hole (it should be no larger than 12 mm for a 7/16" bolt), and the thread depth is around 6 mm rather than the required 9.5 mm.

LVV Certifiers are asked to take special care to ensure that these non-compliant doubler plates are not used. The accompanying photos show the difference between these plates and correctly-dimensioned plates.

LVV Standard 175-00 (Seatbelt Anchorages) requires that a doubler plate must have a hole that has a bolt clearance of no greater than 1 mm; and on the underside of the plate a permanently-fixed nut or threaded section of steel material, having a minimum full thread depth of 9.5 mm.

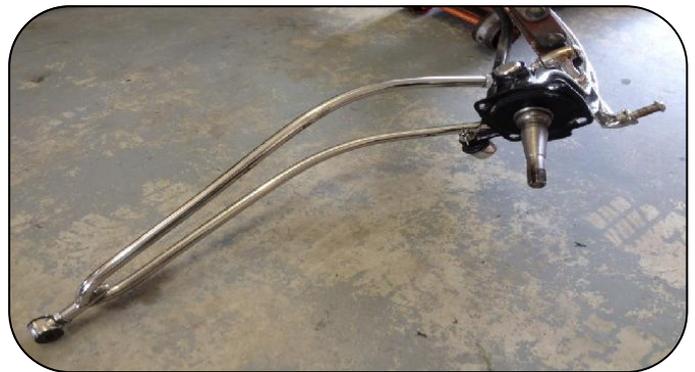
Junior's Radius Rods Pass Crash-test

It's always good to see a product tested - provided on-one gets hurt! A car with a set of hairpin radius rods made by Junior's Kustom Rides & Classics in Wellington was involved in a light impact recently (not because of any mechanical problem), and this photo shows how well the radius rod performed, progressively bending without any complete failure. Good job guys!

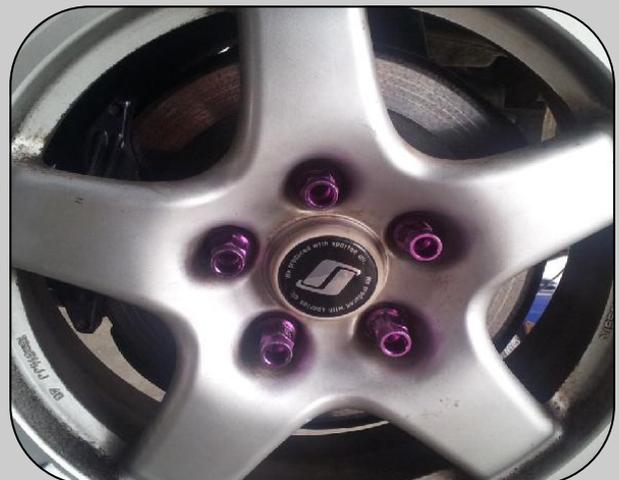
Watch for Aluminium Wheel Nuts

Occasionally LVVTA has it reported by LVV Certifiers that vehicle owners are turning up for LVV certification with aftermarket wheels fitted, which are attached with aluminium wheel nuts. LVVTA emphasises that due to an inherent lack of tensile strength in commonly-available aluminium compared to high tensile steel, aluminium wheel nuts must never be used.

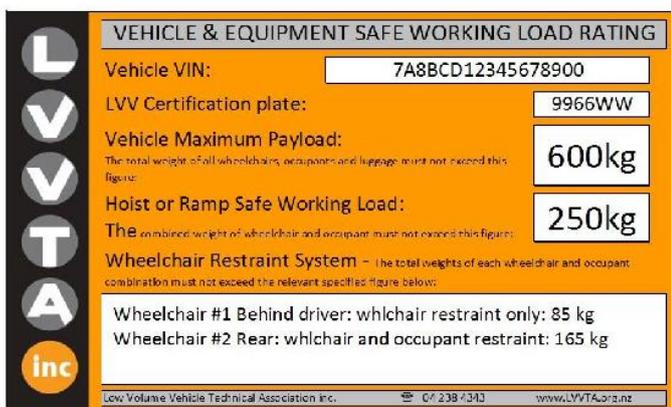
This label provides information on the maximum loads the vehicle and its equipment can safely operate with. It allows operators and users to check that the vehicle is suitable and safe, by listing the maximum payload (total weight of all occupants, wheelchairs and luggage) of the vehicle, the hoist or ramp maximum rating, and the wheelchair tie-down restraint ratings. This label will be located in an area visible to the hoist or ramp operator.

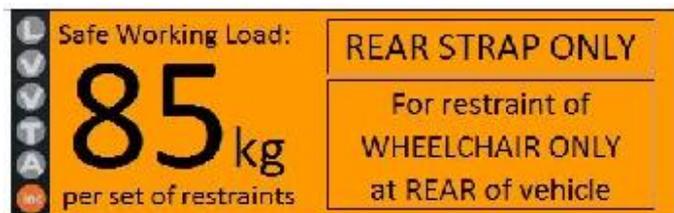
Wheelchair restraint labels:

In conjunction with the VESWL label, each wheelchair restraint system will be labelled with its maximum combined safe working load. The most common rating is 85 kg, meaning that a set of 4 restraint straps together are suitable for a wheelchair weighing up to 85 kg. For pairs of restraints that must only be fitted to the front or rear of the wheelchair, the label will identify the correct position.

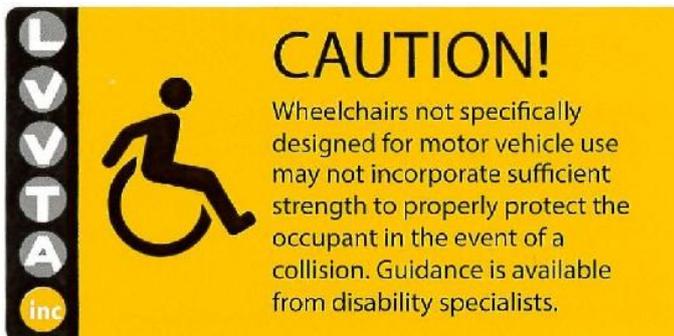
Wheelchair advice label:

The majority of wheelchairs in use are not as safe as a vehicle seat in the event of a crash. A label is provided in a prominent place to notify users, and recommend seeking professional advice.

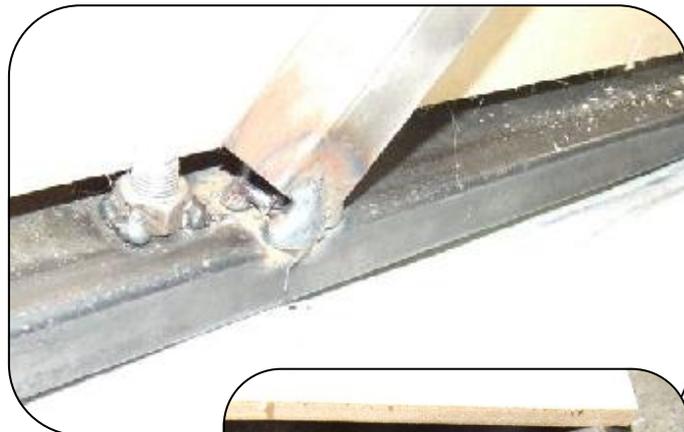
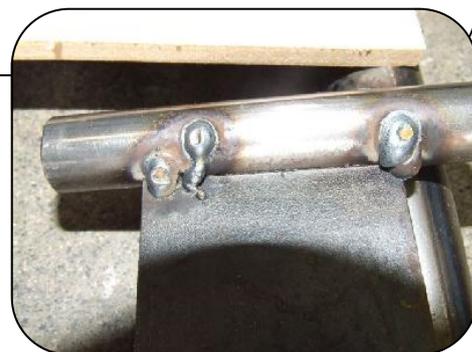
The DC believes the complaint raises serious safety concerns. A CPEng is expected to have public safety upmost in their mind and to carefully supervise the construction of all their designs including those that are to be certified. Any error may have serious consequences. The DC rejected Mr Munro's statement in the final submission that health and safety concerns do not apply because 'nothing happened'. The LVVTA also alleged a degree of negligence by Mr Munro relating to cases where he: provided certification requests to the LVVTA for the wrong vehicle; submitted finite element analyses to the LVVTA which relate to components other than those for which certification was sought; and certified a weld which later failed under the weight of a vehicle's occupant.

The photographs above and right show the type of engineering deficiencies found on vehicles LVV certified by Munro that led to the complaint being made by LVVTA to IPENZ.
